In-service Contamination of Thermal Acoustic Insulation

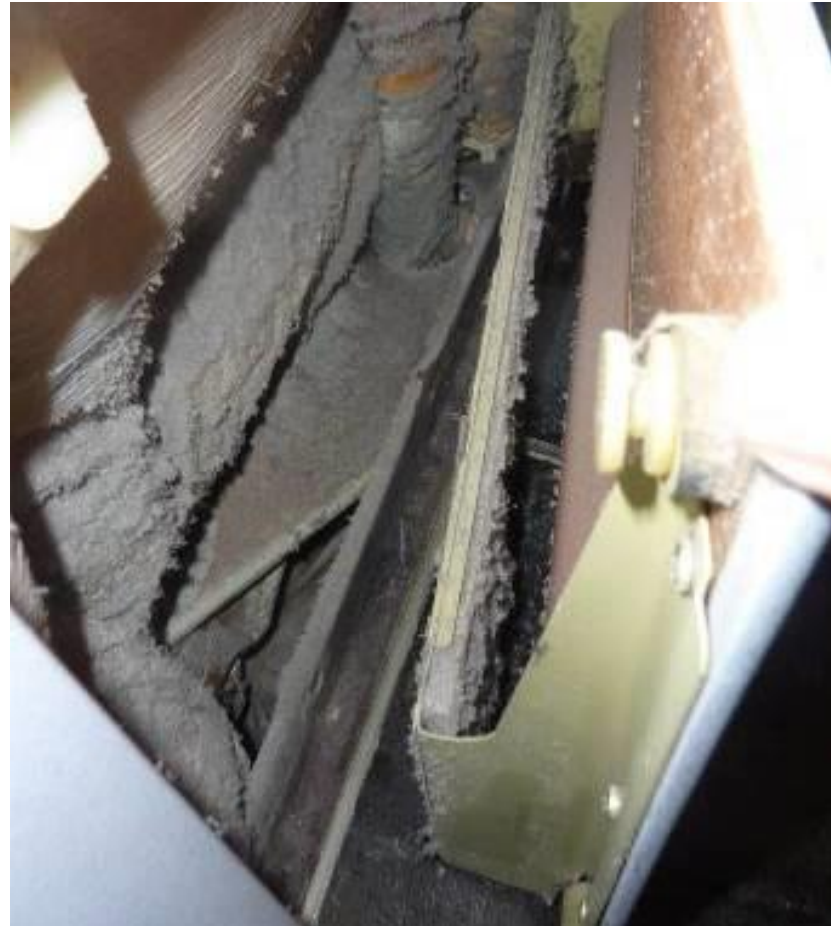
**Typical dust/lint
above cabin floor
behind dado panel**

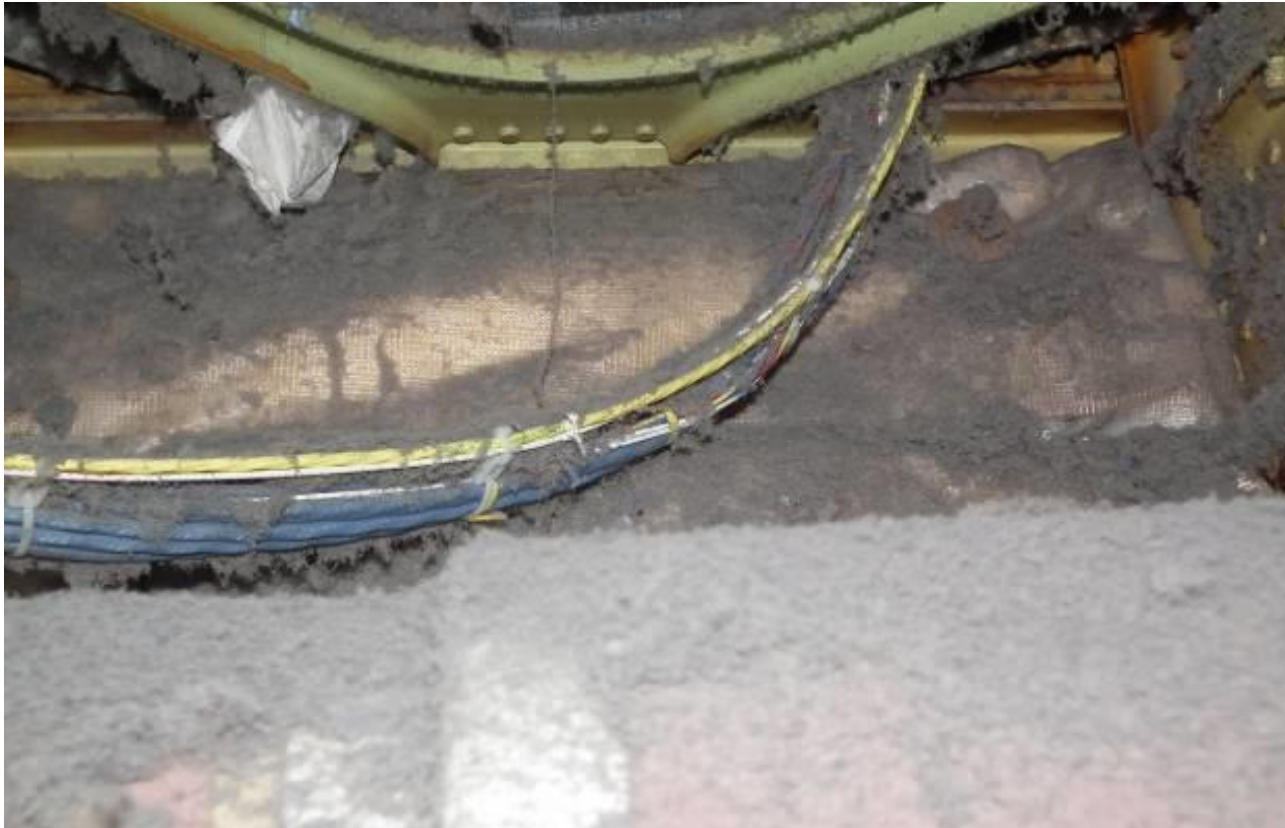
Typical dust/lint below cabin floor

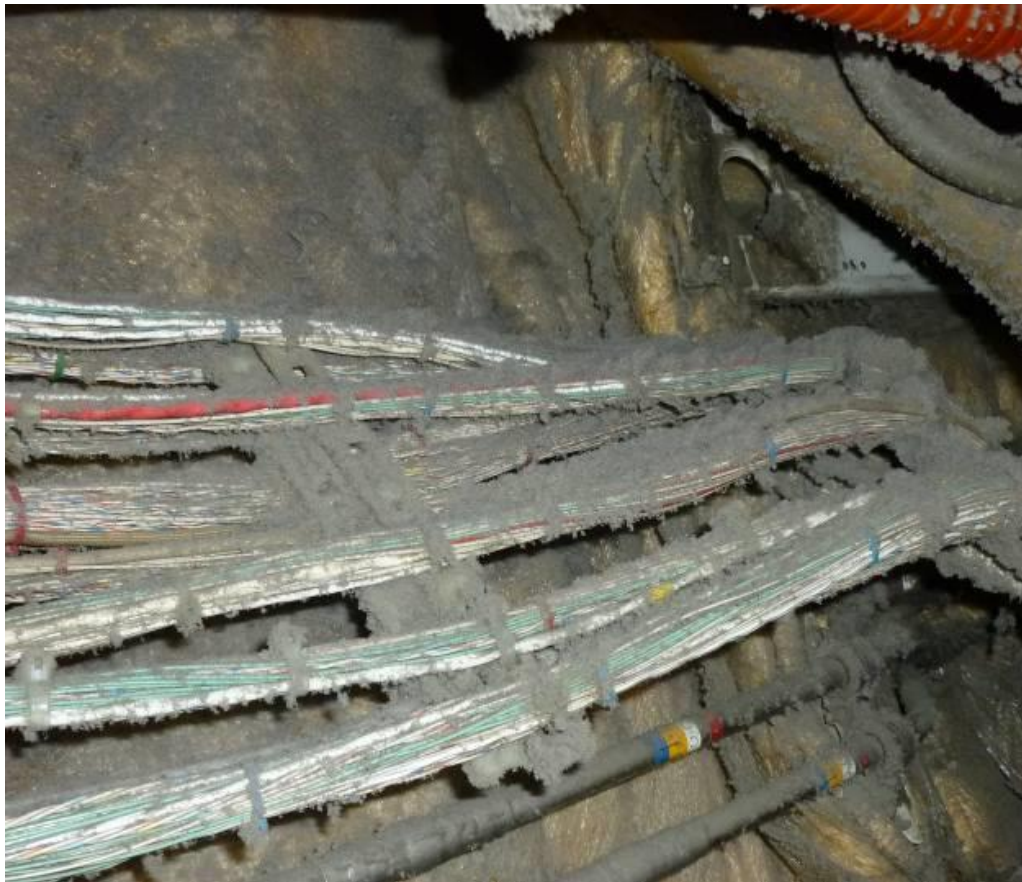
Contaminated EWIS and TAI in cheek near air recirculation inlet

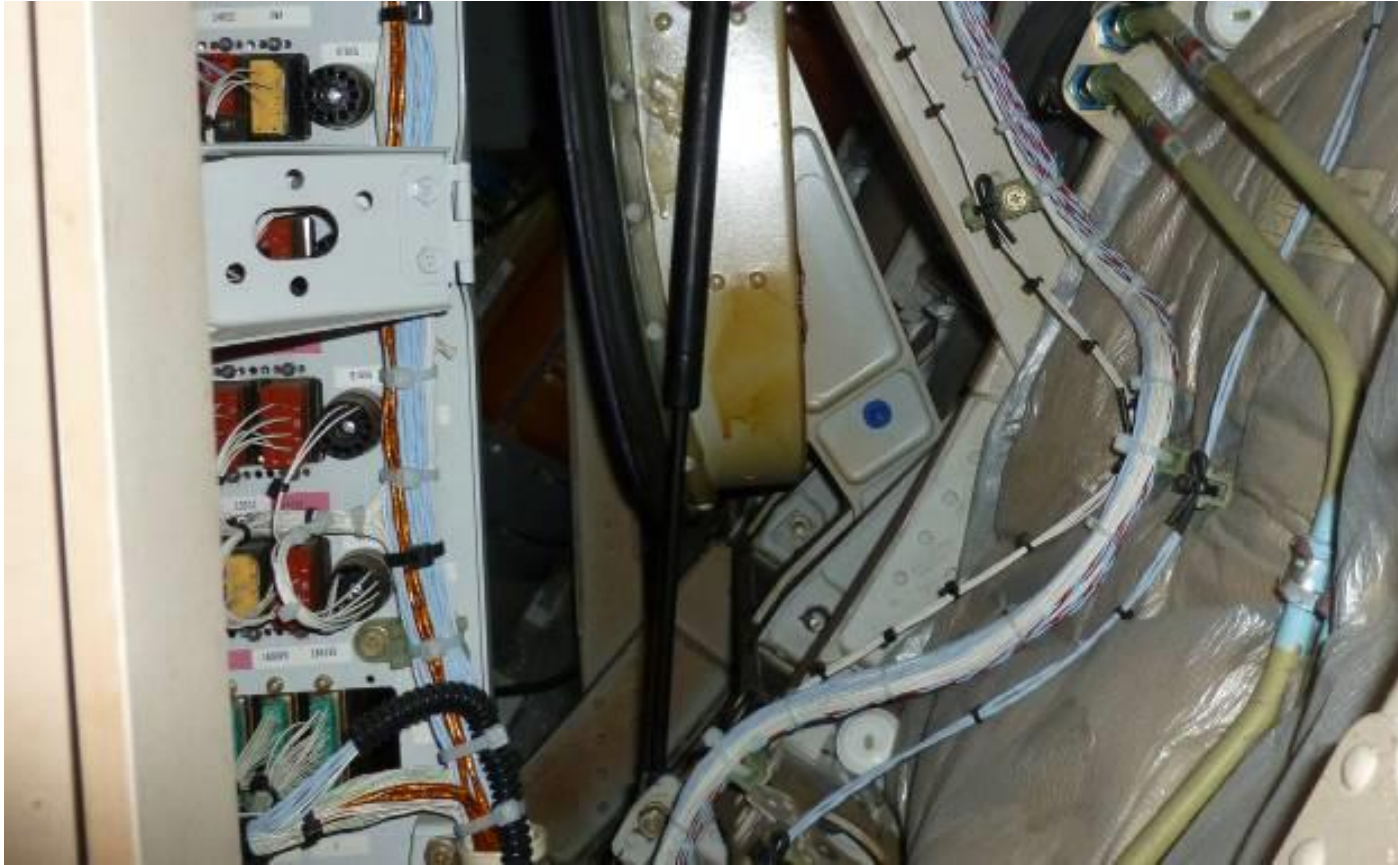
Avionics bays - EWIS and TAI much cleaner

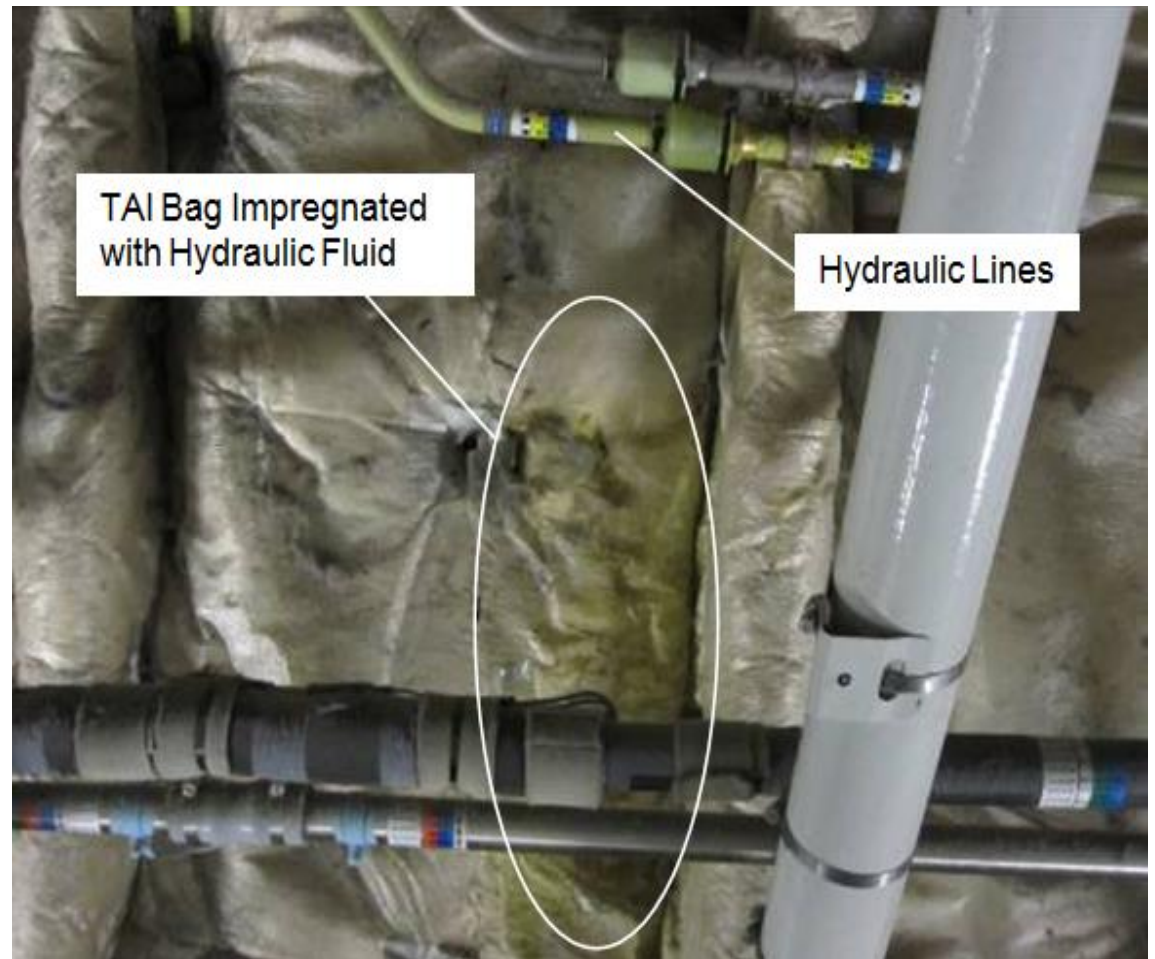
Hydraulic Oil

- Hydraulic oil – remains a threat (see picture)
- Corrosion Inhibiting Compound (CIC) – none found. (testing previously shown variation in flammability of CICs)
- Food wrappers – relatively common

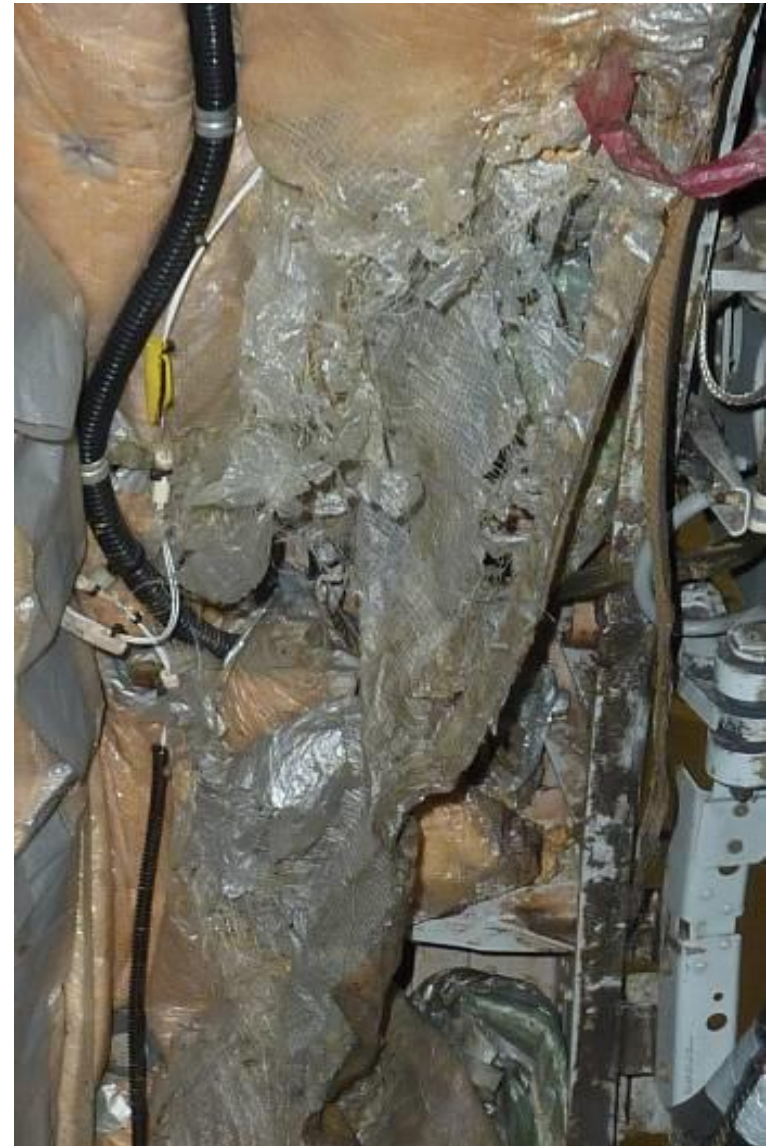
- Moisture degradation of TAI at door surround – one occurrence found
- Moisture degradation of TAI in keel – one occurrence found

**Moisture degraded TAI
at door surround**
