In-service Contamination of Thermal Acoustic Insulation

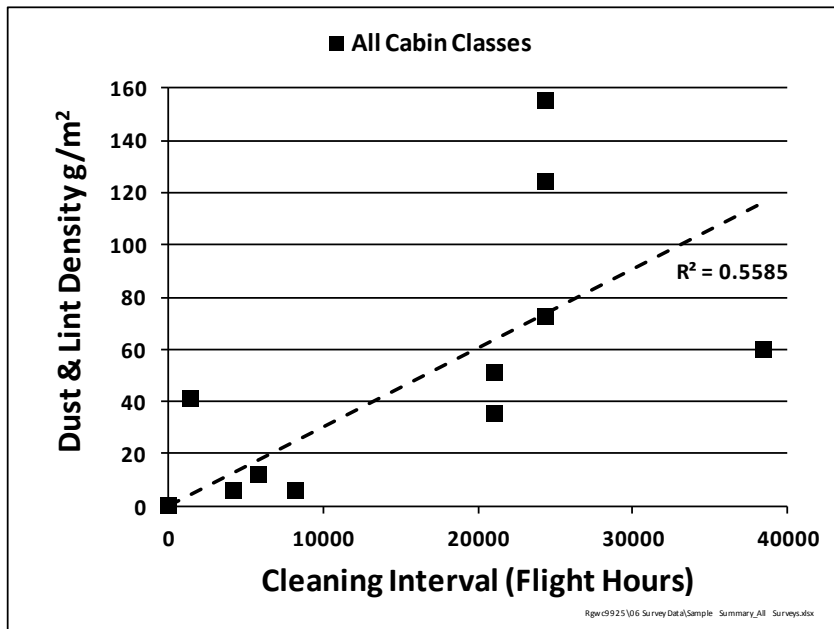
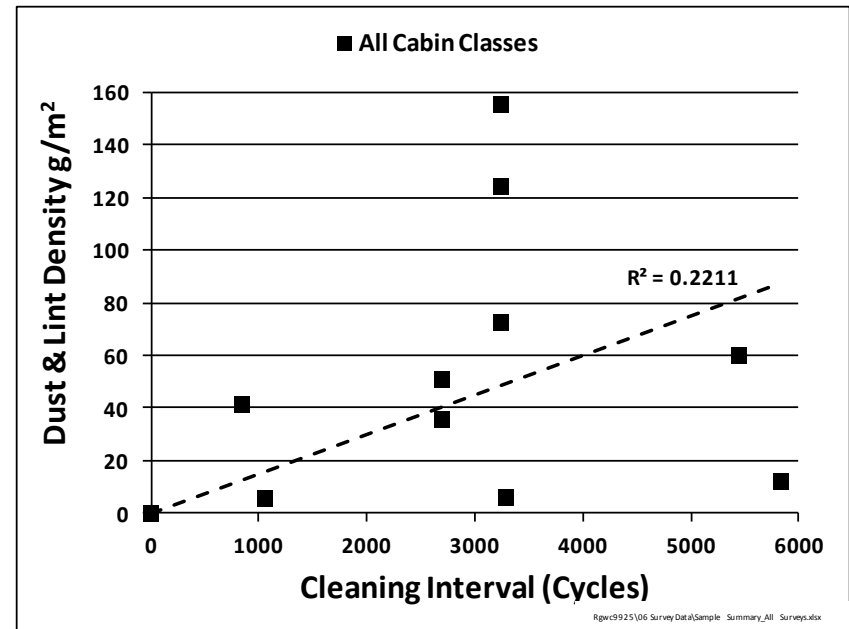
Dust/lint accumulation appears to correlate better with Hours than Cycles

Flight Hours

Flight Cycles

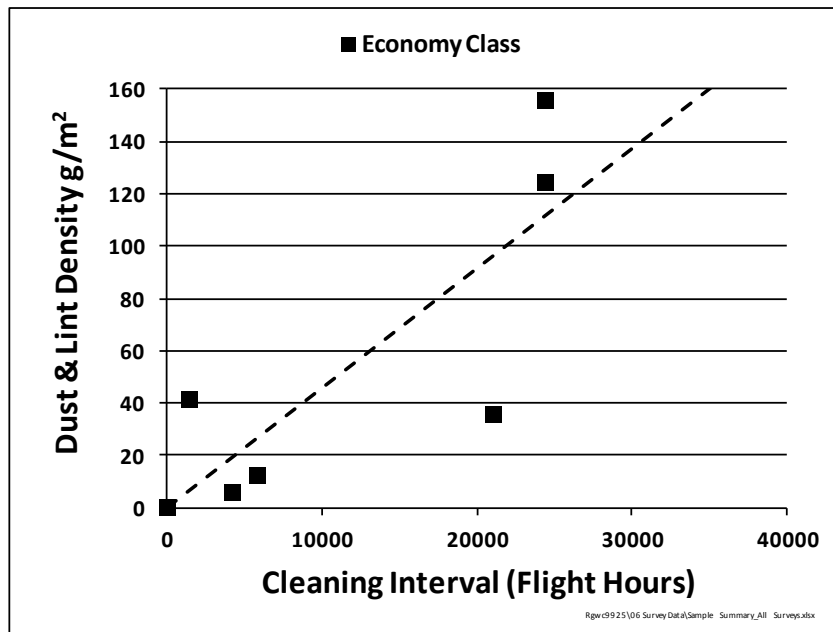
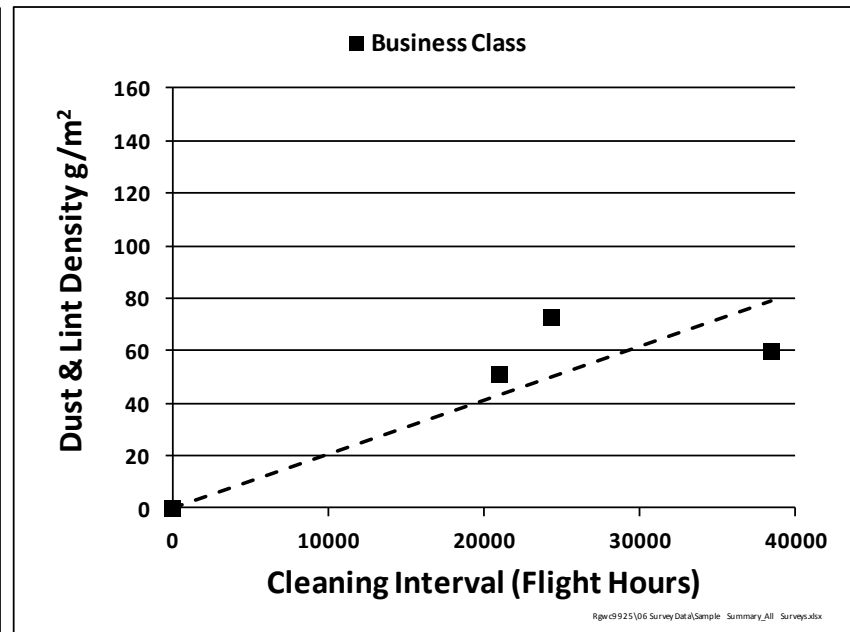
Dust/lint accumulation rate appears to be greater adjacent to economy class than business class

Economy Class

Business Class

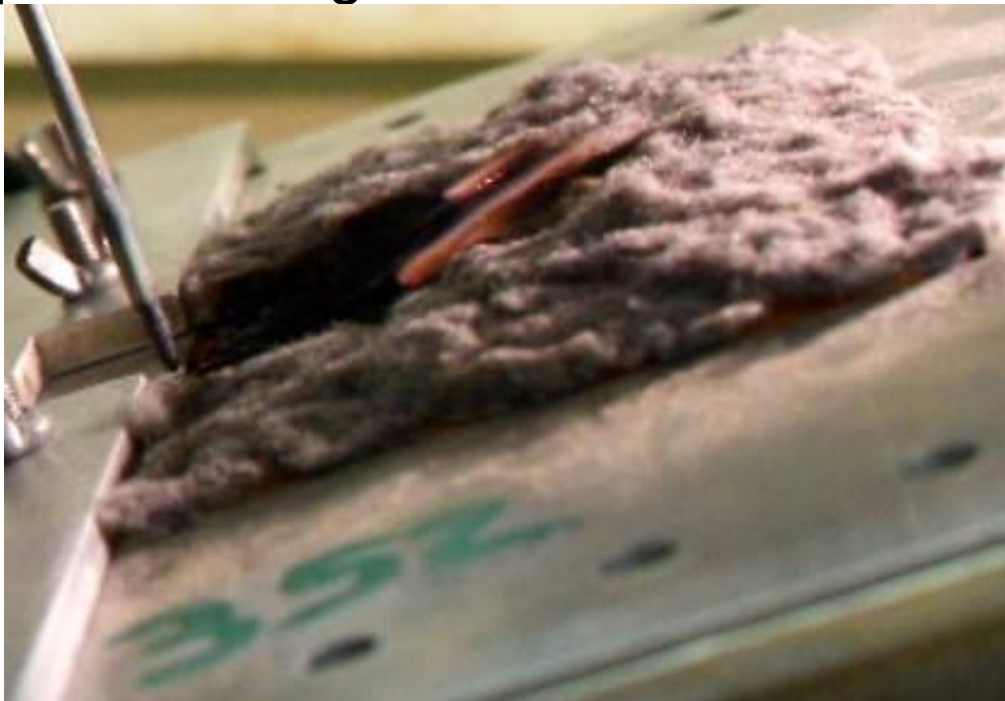
- **Transport Canada Arc Test Rig Used**
 - Dust/lint laid on Kapton/fiberglass blanket
 - Ambient temperature 20 deg C (no radiant heat)
 - Sample at 20 degrees from horizontal

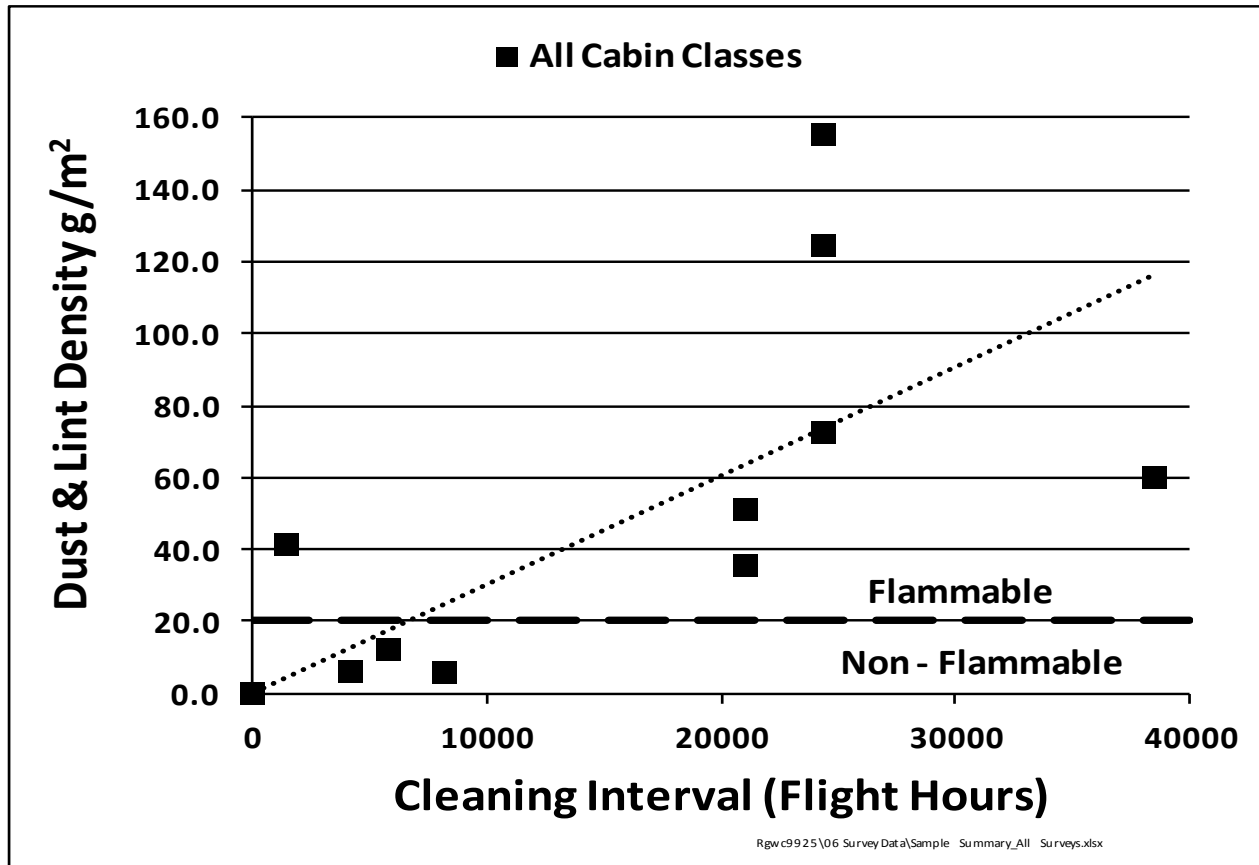
- **The threshold level required for dust and lint to be ignitable by an electrical arc and propagate, when contaminating the surface of TAI at ambient temperature, is in the region of 20 g/m²**
- **Levels of dust and lint above this threshold were observed on EWIS and TAI on the majority of aircraft surveyed**
